Estruturas Projetadas, Construídas e Existentes

Fernando Stucchi

Workshop *fib*MC2020 - São Paulo 29-09-2017

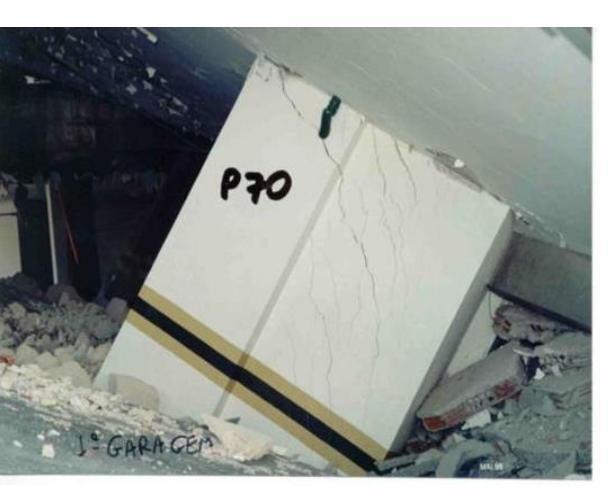
Inclination of P70 after collapse

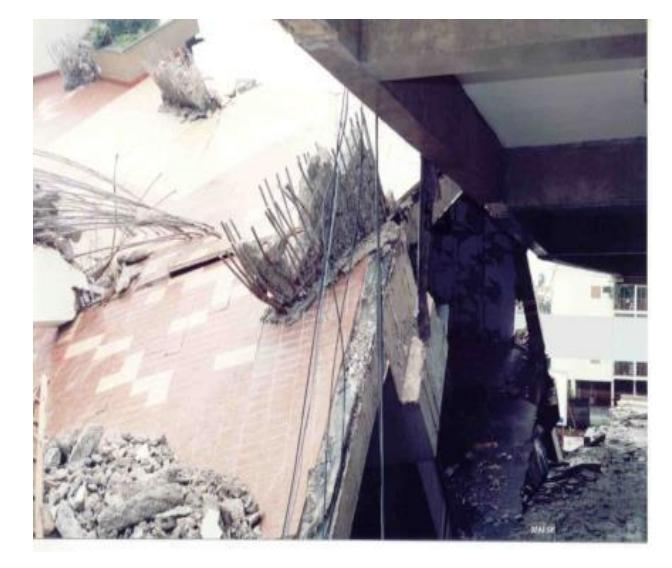
Tensile failure at PUC level

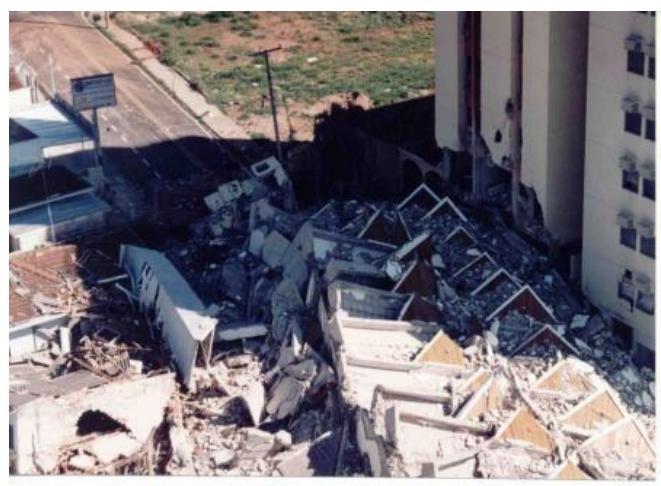
Floors upside down

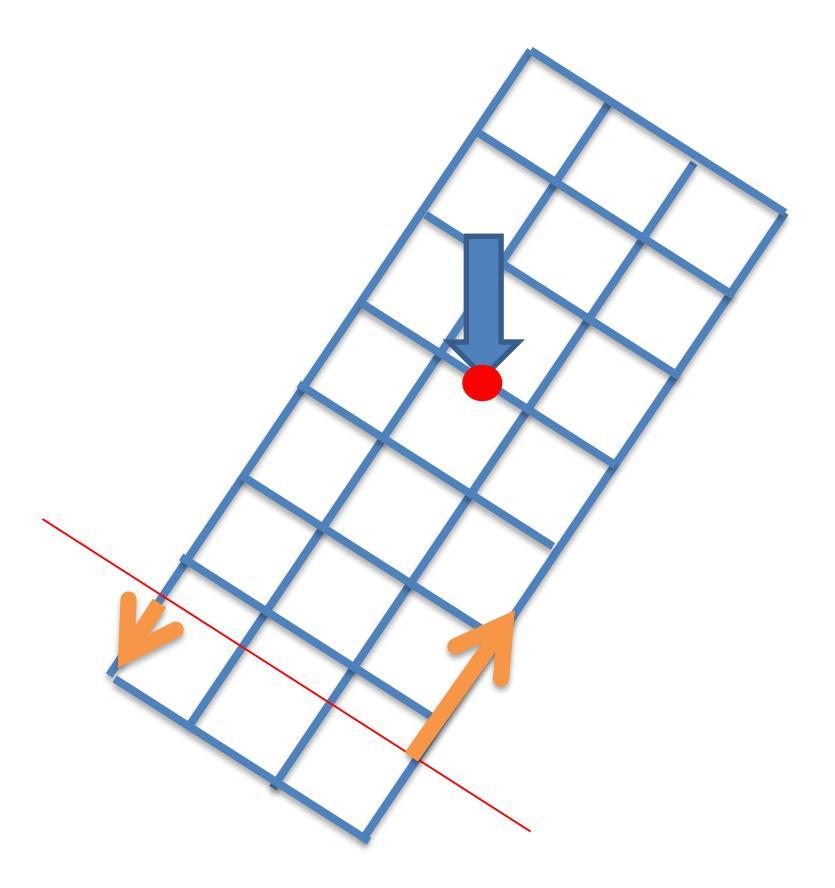
Column axial forces just before collapse

actions, the pile load were critical in the P61/62 ranging from 1440 to 1770kN. For P70

pile loads vary from 1740 to 1790kN. Values higher than 1500kN and not acceptable.

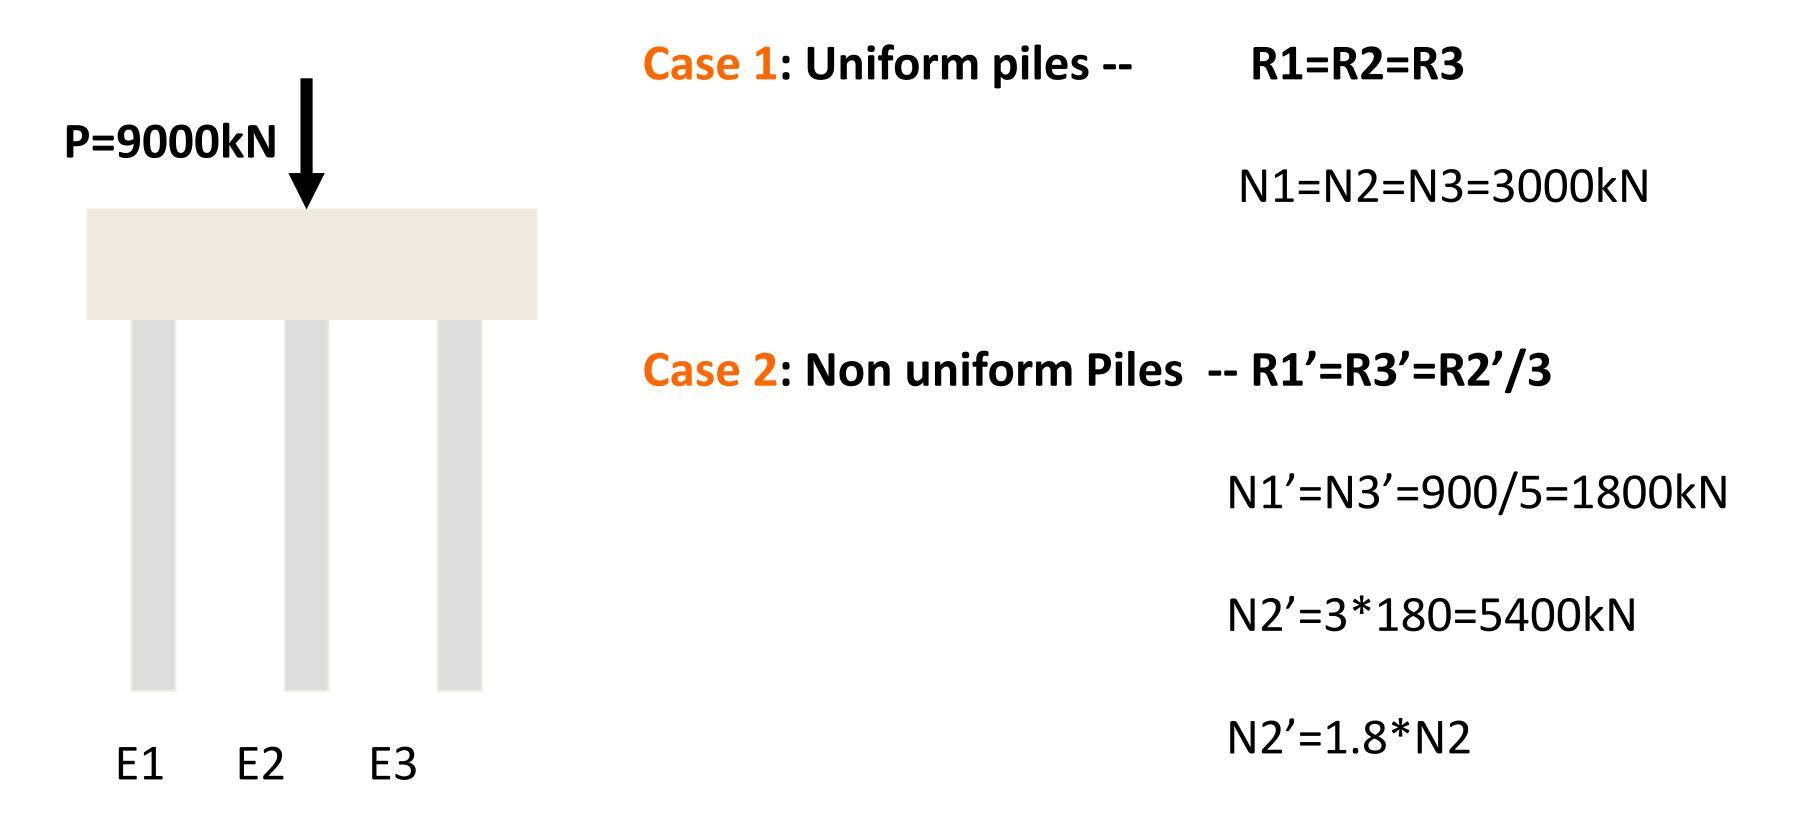
3.6. Piles with different stiffness supporting the same cap. **Hypothetic Example**

The results show in first place a great sensitivity to the variation of stiffness. Secondly they show that it is not difficult to obtain pile loads overpassing the established structural limit between 2400 and 2800kN. The maximum pile load found were 3570kN, applied to the pile E108.

We consider, therefore, that the decisive factor of the collapse was the application of the conventional criterion of uniformly stiff piles to a case of short piles with point in rock were the geotechnical load capacity is much higher than the structural strength.

As we found no other cause for the collapse, we decided to define this one as the probable cause, and suggest a change in our related codes.
