Estruturas Projetadas, Construídas e Existentes

Fernando Stucchi

Workshop *fib*MC2020 - São Paulo 29-09-2017

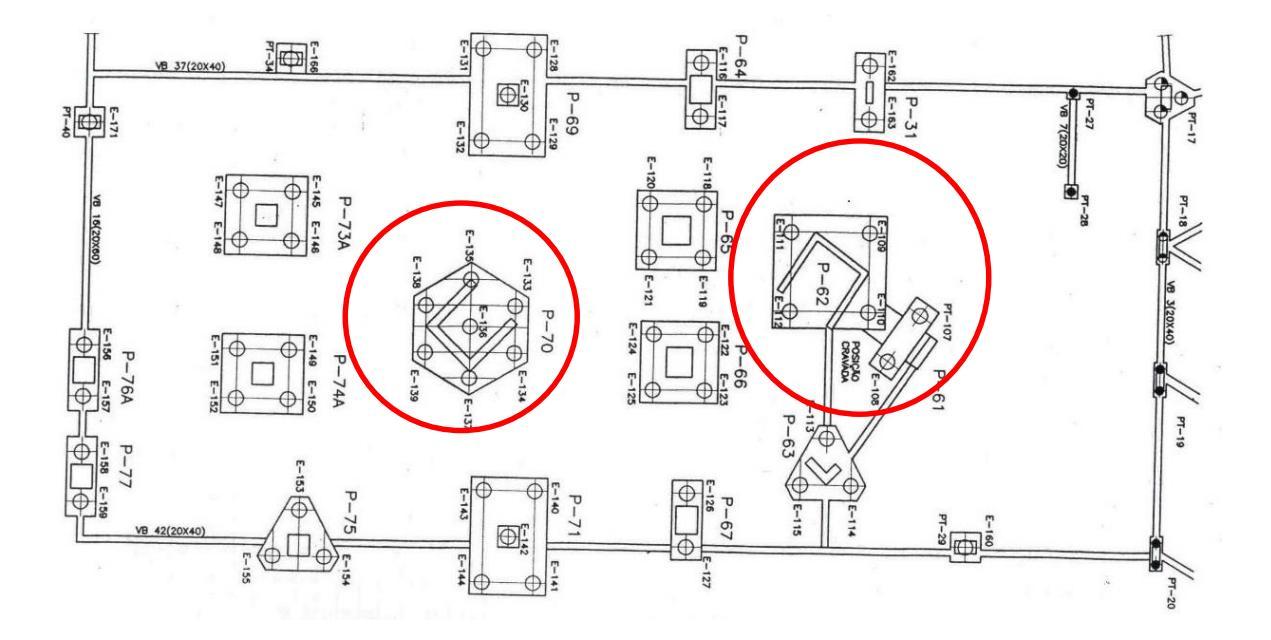
ITALY TOWER COLLAPSE

- Below the ground floor are the foundations (no basements) built up of caps on Franki piles $\varphi52$ cm.

These piles were performed with lengths around 10 m.

- The profile of the subsoil consists of a thick layer of loose clayey sand, based on a compact sand layer

- on top of the sandstone. The piles were practically supported on sandstone. The water level is 3 m deep.
